## Aviation Safety

# Maintainer

Issue 1/2003

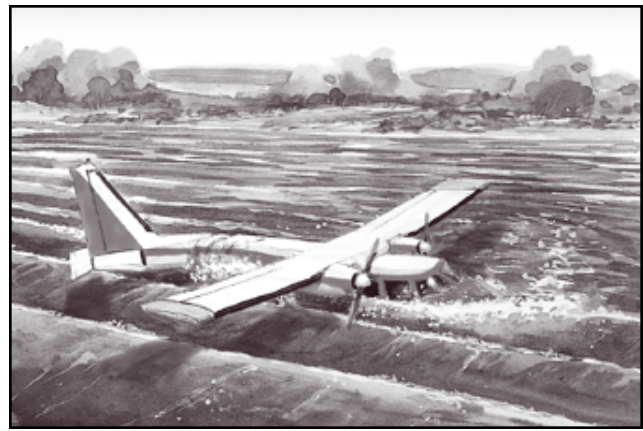
Two hours passed before the rescue efforts started, when a boy playing nearby observed the airplane 300 m from shore and notified authorities. The two engines were functioning on impact. But were they developing the power that they should have been producing? Investigation of the left engine revealed that cylinders 2, 4, 5 and 6 showed signs of blow-by and the compression rings for pistons 1, 2 and 4 were broken. The rocker arms for cylinder 6 had been reversed at installation. Examination of the right engine revealed that the model of piston used for cylinder 3 was incorrect; a low compression model had been installed instead of a high

compression one. Pistons 1, 2, 4, 5 and 6 showed signs of significant blow-by. The compression rings on pistons 1, 4, 5 and 6 were broken, the head of piston 5 was punctured, the wear on piston 6 exceeded the manufacturer's standard and it was cracked on the bottom of the forward scallop. According to the maintenance schedule, one cylinder in each row should have been removed to allow internal examination of the engines. This examination should have been entered in the engine log. No documentation indicating that this work had been done was found in the aircraft technical records. 📁

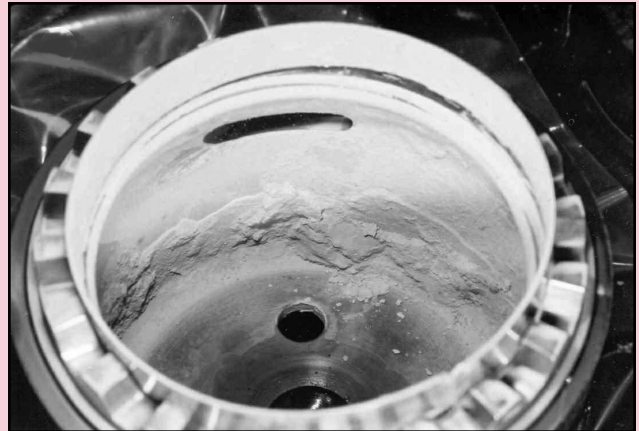
Only four grams of accumulated sand or dust, which flakes off the inner walls of the gas generator shaft section of the Turbomeca Arriel 1 engine, can have a catastrophic effect on the rear bearing. The pilot can experience a very sudden engine failure, and if he's doing heli-logging or fire fighting, it is likely that a crash will ensue, as he has very little margin for error and very few safe-landing sites available. Four grams is about double the amount of salt that you put on your fries—it's not very much. The *Airworthiness Directive (AD) 90-064B* and the *Turbomeca Service Bulletin A292 72 0230* emphasize the importance of regular inspection, adhering to the maintenance schedule adapted to operations in dusty environments, and the use of an air filter to lower the risk of the ingestion of dust and sand when operating in a dusty or corrosive environment. Construction sites, heli-logging, crop-dusting, cement factories, and areas where volcanic ash may be present are only a few examples of where these conditions exist. As an aircraft maintenance engineer, your responsibility is to ensure that the necessary steps are taken to prevent this type of engine failure. The air filter is a great help, but cannot prevent very fine dust

particles from entering and accumulating in the engine. The risks remain, and only the diligent application of the manufacturer's recommendations can ensure the continued airworthiness of this engine. You may not have been made aware of previous exposure of the engine to such an environment, so strict adherence to the AD requirements will help ensure safe flight. Remember, you have the last say on airworthiness. 📧
